Foreign-born Semi Driver Dies After Driving Over Embankment

Incident Number: 09KY071

Kentucky Fatality Assessment and Control Evaluation (FACE) Program

Release Date: August 3, 2010

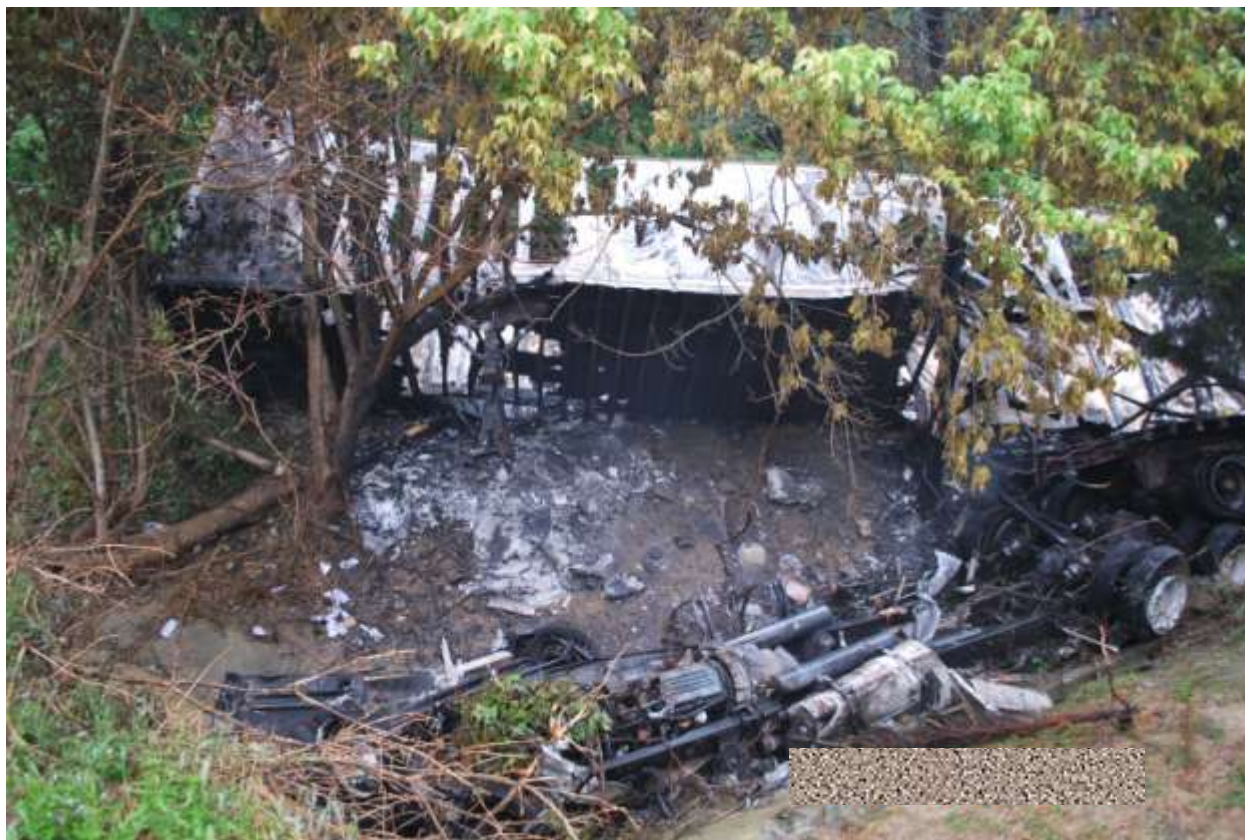
Photograph of the semi tractor-trailer involved in this incident. Photograph courtesy of local official.

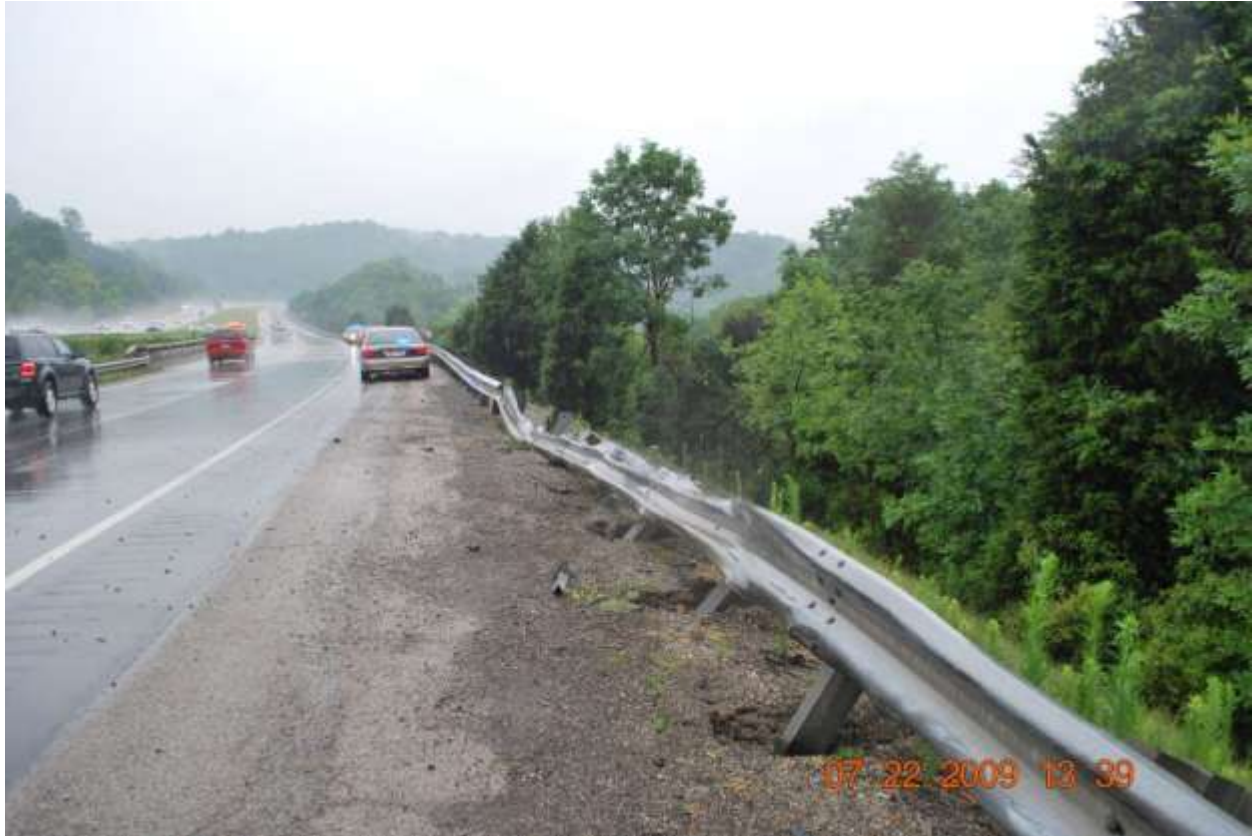
At approximately 11:30 AM, the truck driver had been enroute for approximately 50 miles and was headed southwest on a rural, four-lane interstate. It was raining, the asphalt pavement was wet, and the speed limit was 70 miles per hour. The local terrain was hilly, and the tractor-trailer was headed downhill into a curve when the driver drove off the pavement on the right side over the emergency lane, over a guardrail, then traveled 185 feet through dense trees and into a ravine. With the fuel tanks damaged, the tractor overturned and the trailer disengaged from the fifth-wheel. A fire ensued; the tractor flipped over, ejecting the driver and the tractor came to rest on its top. The trailer settled in an upright position partially across the overturned tractor.

Location where semi tractor-trailer driver drove off of interstate into ravine. Photograph courtesy of local official.

Recommendation No. 5: A comprehensive motor vehicle safety assessment of Kentucky’s interstate system needs to be performed in the area where the collision took place.

institute a seatbelt training program, the Federal Motor Carrier Safety Administration developed the “Commercial Vehicle Safety Belt Program”. A manual, “[Increasing Safety Belt Use in Your Company](http://www.fmcsa.dot.gov/safety-security/safety-belt/increasing-safetybelt-usage-manual.htm)” is available to help companies develop a seatbelt usage program and is available at <http://www.fmcsa.dot.gov/safety-security/safety-belt/increasing-safetybelt-usage-manual.htm>. From January 1, 2009 through December 31, 2009 on the two- to three- mile stretch of interstate where the collision described in this report occurred, there were 17 collisions involving commercial vehicles and three fatalities resulted. This particular stretch of interstate is rural, hilly, curvy, and the speed limit is 70 miles per hour. The State of Kentucky should consider performing a comprehensive motor vehicle safety assessment of this stretch of highway including assessment of roadway curve design, roadway grade, signage including possible warning signage, median and roadside barriers, as well as other highway attributes.
